Monitoring of Dolos Armor Units at Crescent City, California

Glenn B. Myrick and Jeffrey A. Melby

September 2005

Final report

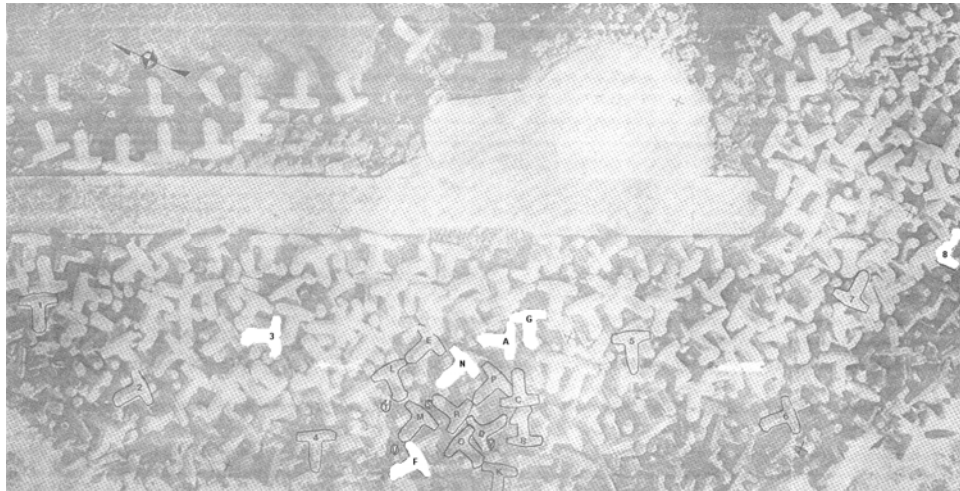
Figure 8. Location of dolosse with significant movement

Of the 26 targeted dolos units and remaining non-targeted unbroken units, six had movement that exceeded the observation thresholds of 0.15 m (0.5 ft) cumulatively since 1986. Only dolos A had exceeded the thresholds since 1999. Details of significant movements can be seen in Figures 8-14 and in Table 1.

However, dolosse A, C, E, and G were recently moved using a crane to verify operation of internal instrumentation (Melby 2002). As such, the movement of these dolosse is not considered significant. Of the remaining dolosse with motion, none had significant movement since 1999.

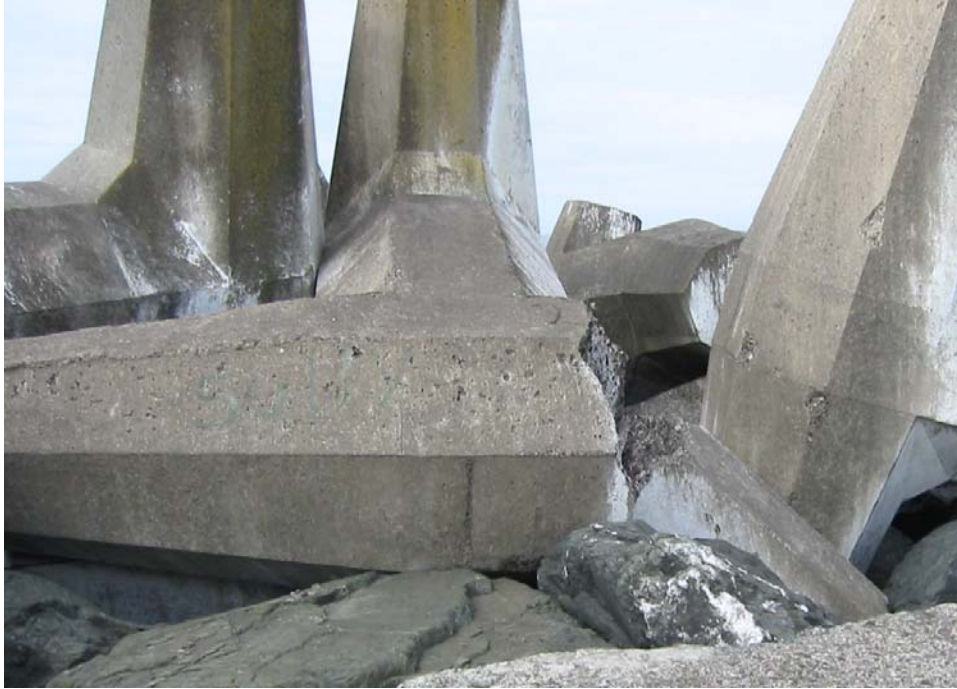
Figure 15. Example of a straight fluke-shank dolos break

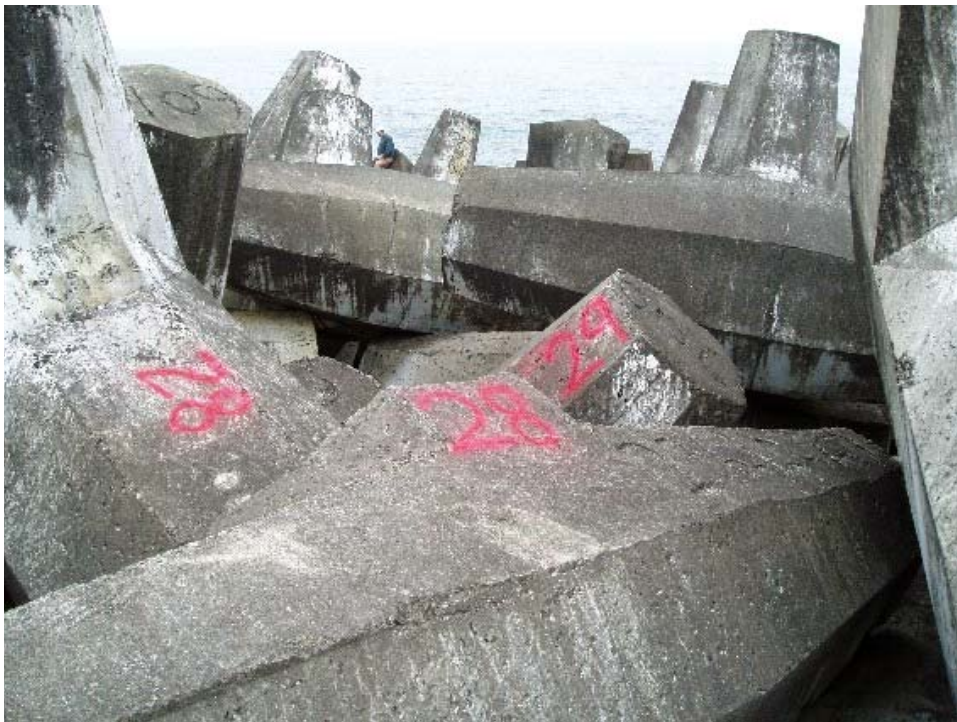
Figure 16. Example of shank-fluke dolos break

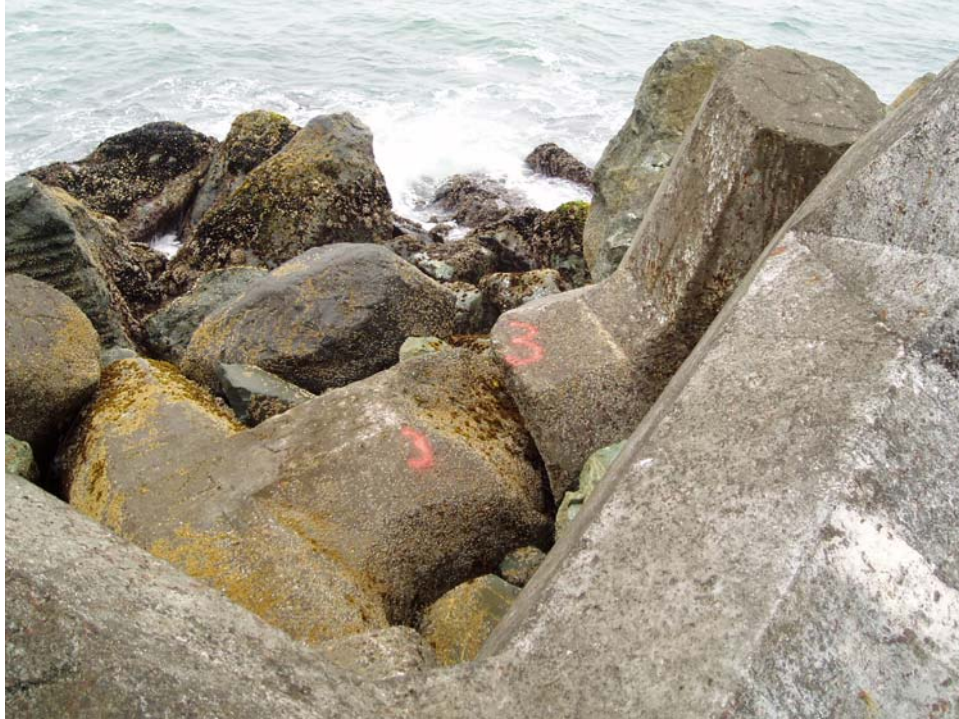
Figure 17. Example of mid-shank dolos break

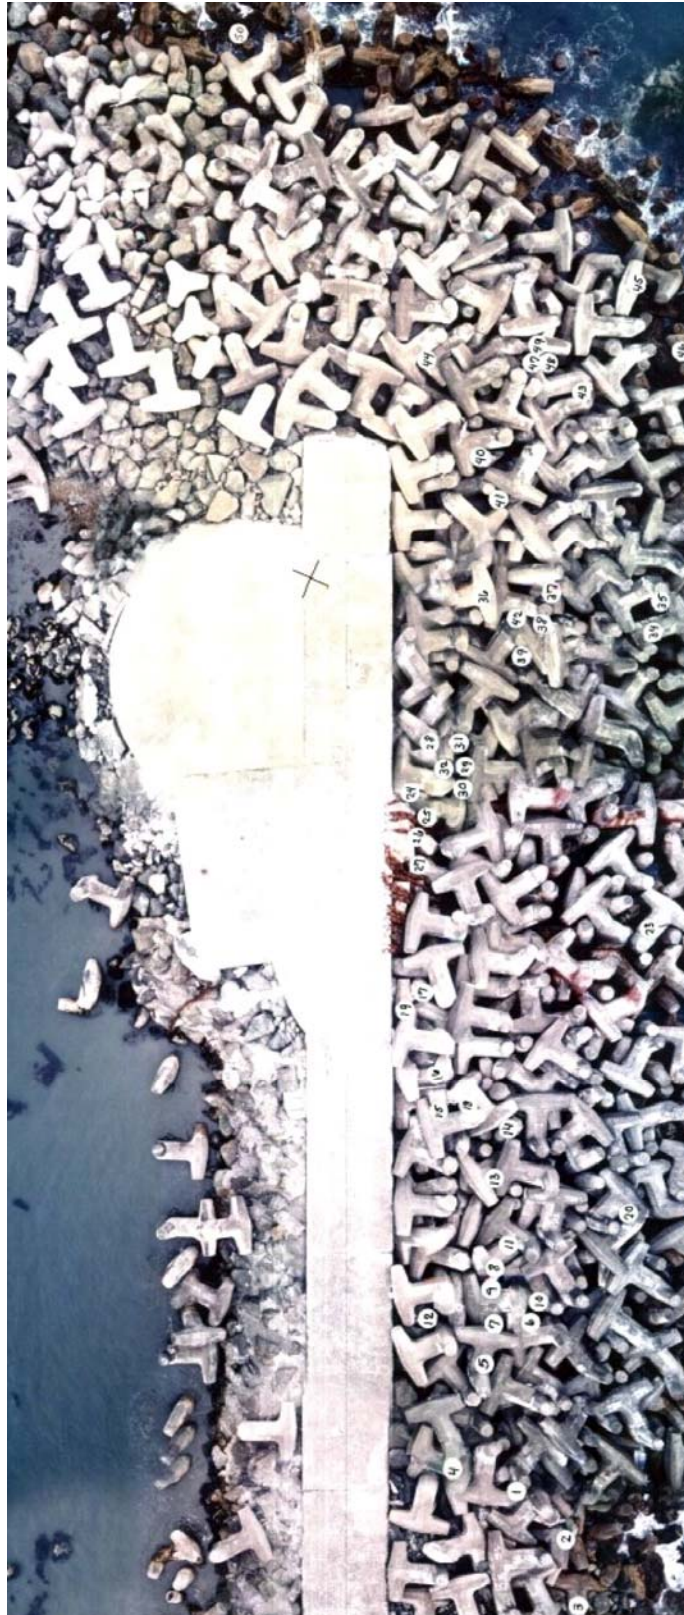
A comprehensive broken armor unit survey of above water dolosse was conducted on August 11, 2004, by Messrs. Myrick and Tolliver and Dr. Melby. This inventory revealed a total of 50 visible broken dolosse of which 14 were cast in 1986 and 36 were cast in 1974. Overall, 33 dolosse were broken at the shank-fluke interfaces (Figures 15 and 16), seven along the shank (Figure 17), two in the fluke, and eight dolosse were broken into 2 or more pieces. The break descriptions of *fluke-shank* and *shank-fluke* are intended to differentiate between a break that is primarily in the fluke from one that is primarily in the shank, respectively. The broken dolos inventory, along with the location of broken dolosse and detailed types of breaks are listed in Table 2 and Figures 18-20. The results of the survey show that there has been no additional breakage since the last detailed comprehensive armor unit survey in 1993 by Melby and Turk.

Figure 18. Overall aerial view of locations of broken/cracked dolosse

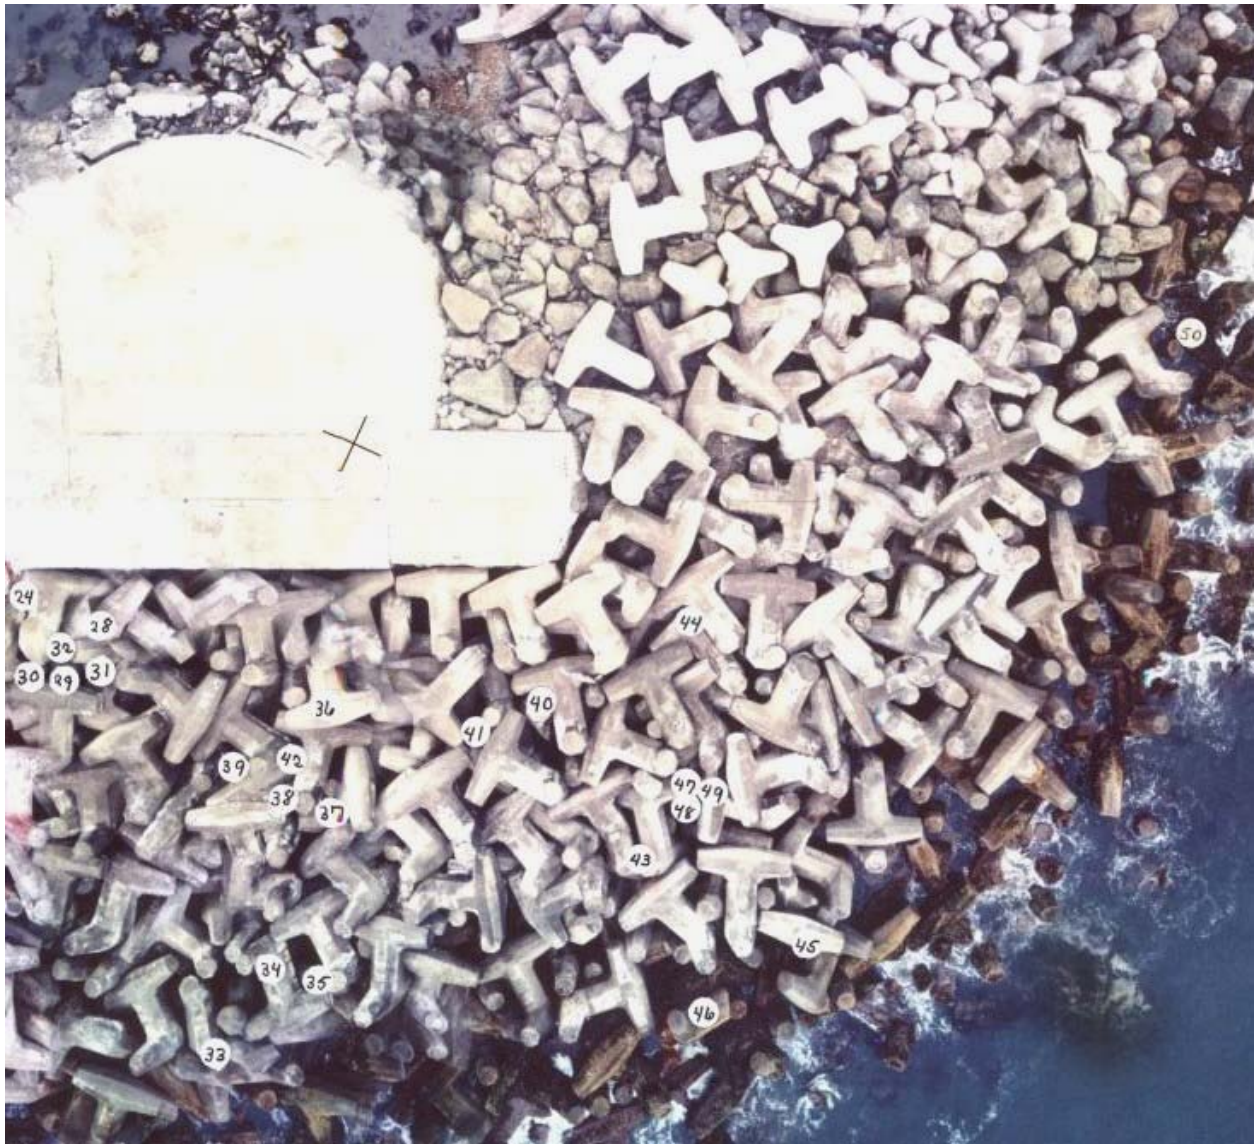
Figure 19. Locations of broken/cracked dolosse along the southerly portion of elbow

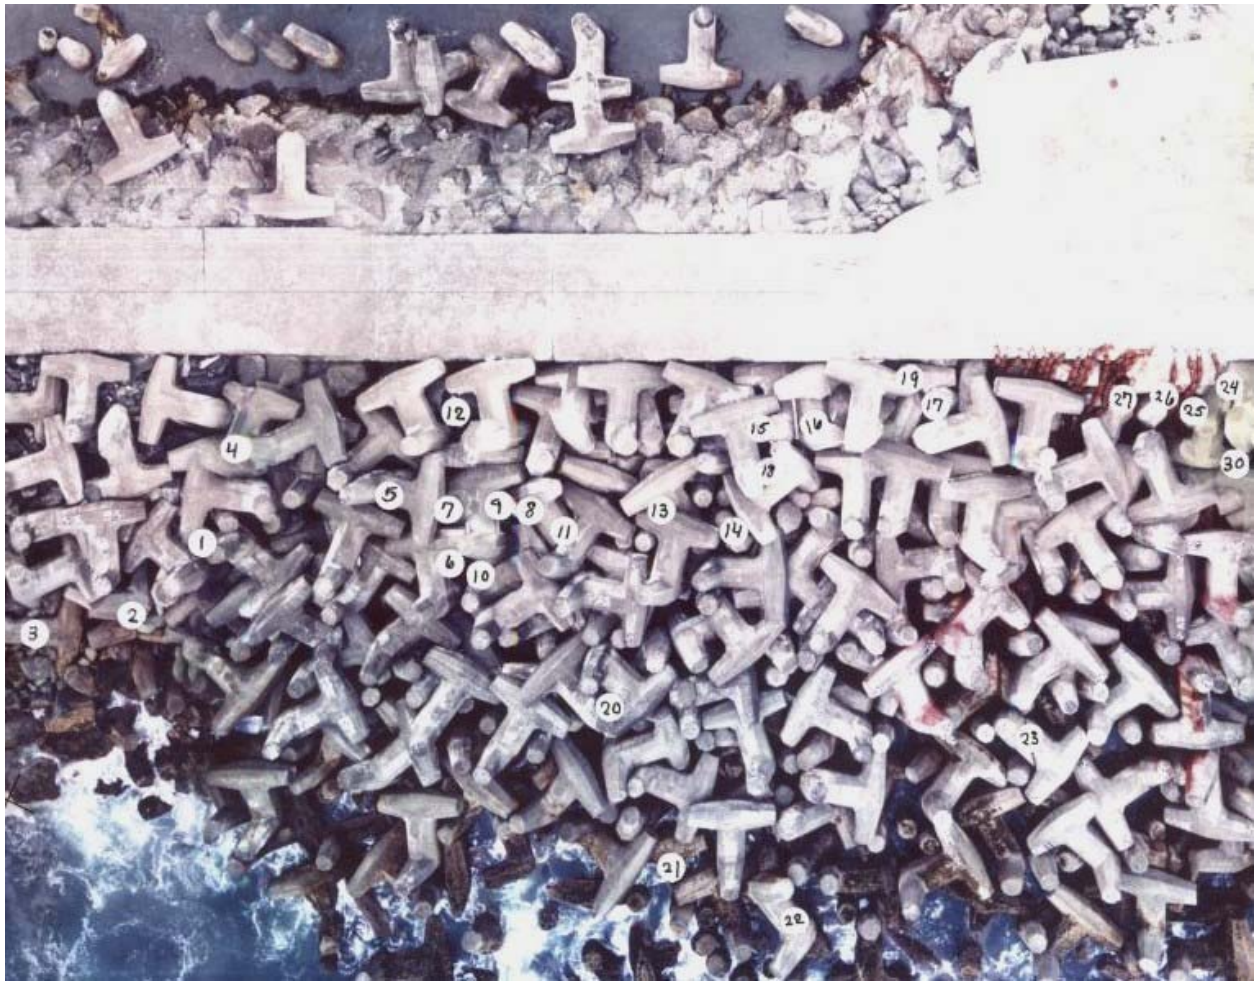
Figure 20. Locations of broken/cracked dolosse along the netherly portion of the elbow

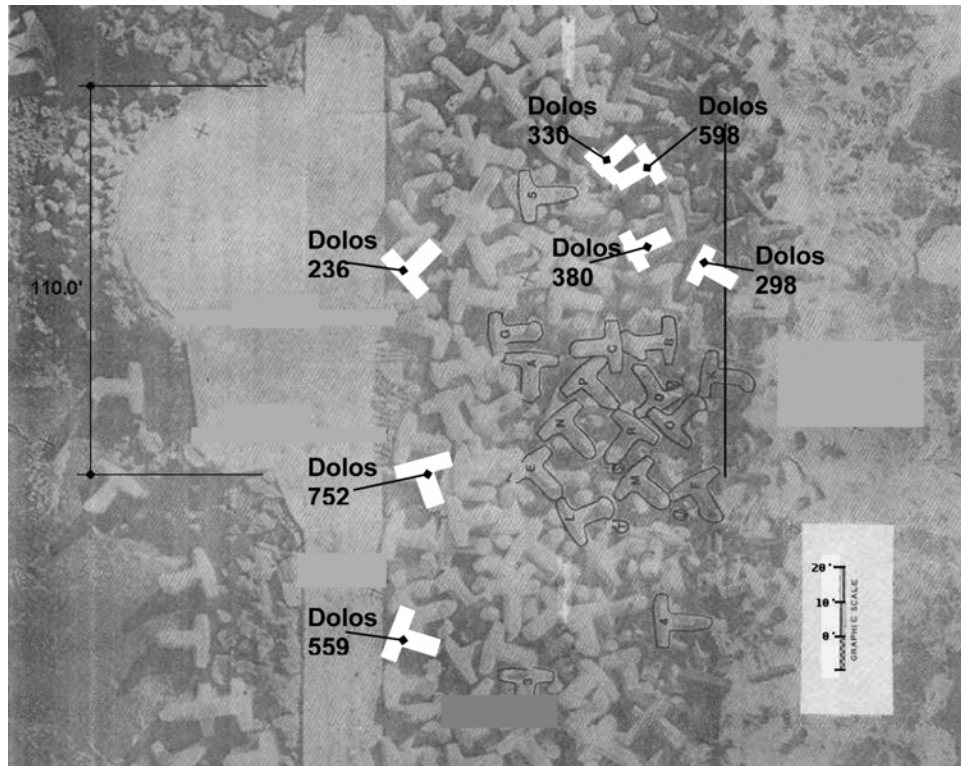
Figure 21. Location of cored dolosse

In August 1995, core samples were obtained from two 1986 dolosse near the cap to determine how the concrete strength had changed as the dolosse aged under repeated loading during the ten years since construction. Core samples were also obtained from one 1974 dolos for comparison of strengths. The 1974 dolos used for coring was a broken unit near the cap and two cores were taken very near the break. In August 1999, core samples were obtained from dolosse just above the still water level. The locations of cored units are shown Figure 21.

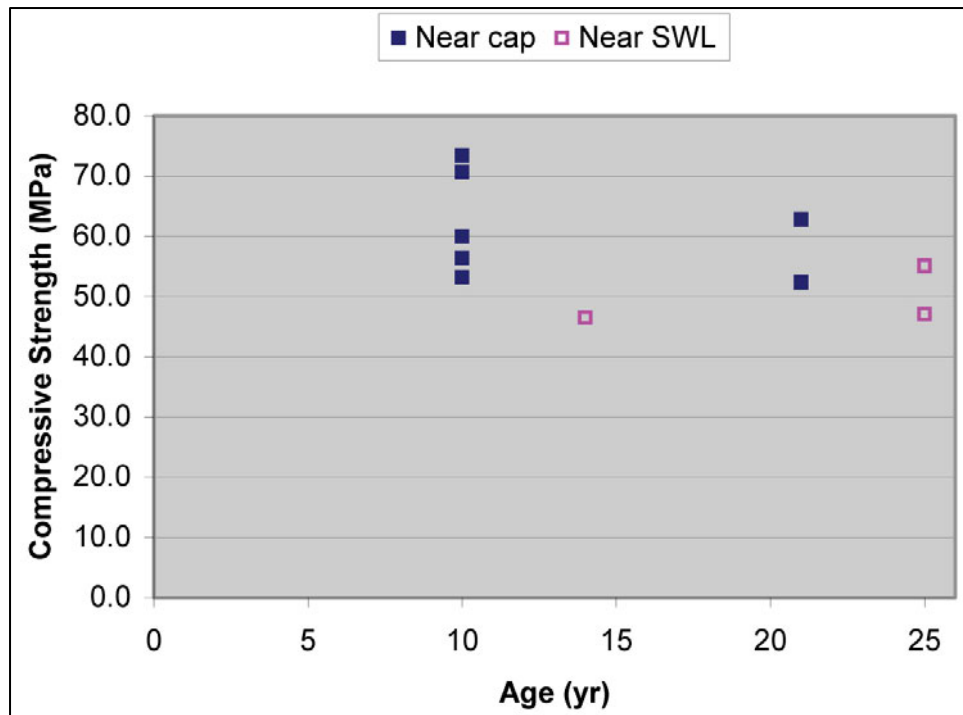
Figure 22. Compressive strength as a function of age

Several observations can be made regarding the strengths listed in Table 3. First, the concrete strength has increased substantially for both the 1986 dolosse and the 1974 dolosse, as expected. In 1995, the average compressive strength for the 1986 dolosse was 62.76 MPa (9,100 psi), the flexural was 10.08 MPa (1,461 psi), and the splitting was 3.90 MPa (565 psi) (not counting the obvious outlier of 2.1 MPa (310 psi)). This compares with the 1986 28-day flexural strength from beams of 6.8 MPa (986 psi). Secondly, the splitting strength was less than half the flexural strength. This is significantly less than predicted by ACI formulae. Contributing to the difference is the fact that the test was non-standard, being done using cylinders rather than beams. Third, the splitting strength was less than the usual estimate of one-tenth the compressive strength while the flexural strength was substantially higher than this. The average splitting strength was 6 percent of the compressive, while the flexural strength was 16 percent of the compressive. Finally, the flexural testing tool developed under this project seemed to predict the flexural strength reasonably well, considering the scatter in the ASTM standard tests. This is encouraging and perhaps warrants further investigation.

To illustrate the increase in strength, Figures 22 and 23 show the compressive and tensile strengths for all dolosse, respectively. Figure 22 shows the compressive strength results as a function of age for dolosse near the cap and near the still water level. Figure 23 shows the flexural tensile strength results as a function of age for dolosse near the cap, near the still water level, and for all 1986 dolosse at casting time (dashed line). Here, age is used on the horizontal axis to separate the 1986 dolosse from the 1974 units and not to show a general trend. Figures 22 and 23 highlight several interesting points concerning the Crescent City dolosse concrete. First, the concrete strength in these units was very high. Typically, concrete armor units are specified to have minimum 28-day compressive and flexural tensile strengths of approximately 35 Mpa and 3.5 Mpa, respectively. The measured strengths were more than double this specification. All 1986 dolosse tested show increased strengths over the as-built average value of 6.8 Mpa. The range of increase is from 9 percent to 76 percent, with the lowest increase being in the most heavily loaded units near the low water level. The mean strength increase of the cap units corresponds crudely to the theoretical increase in strength with time. The units near the low water level show significantly lower strength levels than the units near the cap. This lower strength level could be due to fatigue. A crude theoretical estimate showed that this was the most likely cause; but the reduced strength levels are still greater than the 28-day strength levels.
